PRODUCT AWARENESS

PA0045 -LR350 | CAMSHAFT CARRIER

Application: BMW & MINI 2.0D N47 Variants

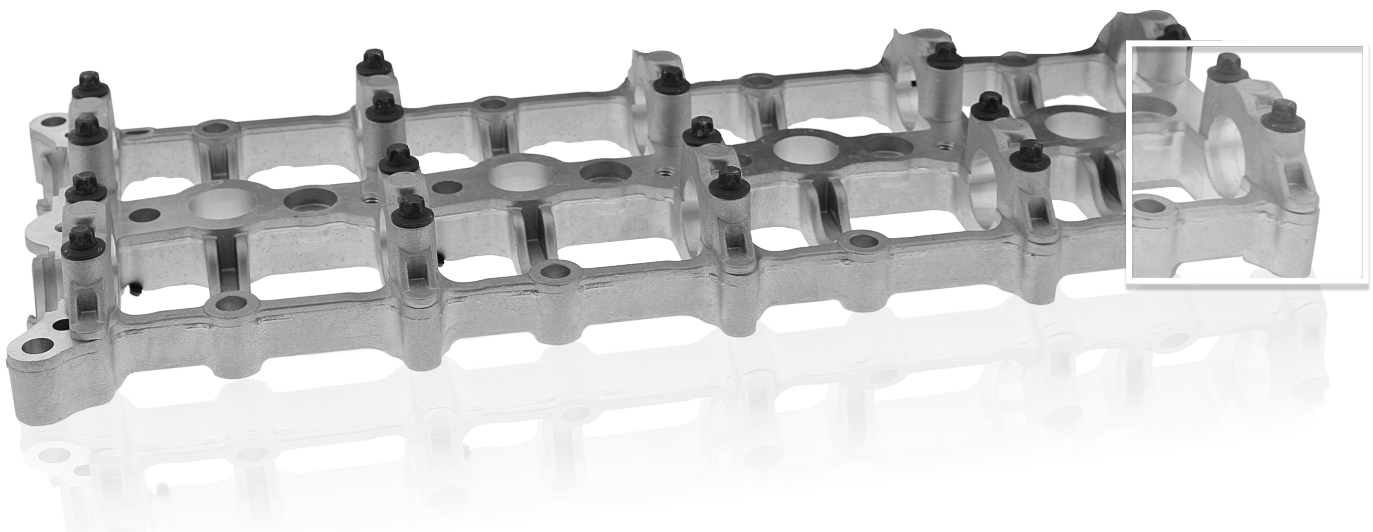
A common occurrence in the BMW N47 engine variants is Timing Chain Kit failure.

When this occurs, the Camshaft Carrier has a tendency to fracture in one corner making it a popular replacement component.

Our LR350 includes all cam caps, cam cap bolts and O-Rings.
